Simple CRX Dash Repair
Mark & Michael Olson
Rev 0, 3/8/2011

We got a spare black dash in addition to the stock blue dash when we bought the 88 CRX-HF shell we decided to restore. The black dash was in pretty good shape with the exception of having two broken mounting tabs, the front center mounting tab and a tab on the back under a metal brace. This how-to explains how we figured out how to make simple repairs such as fixing broken tabs.

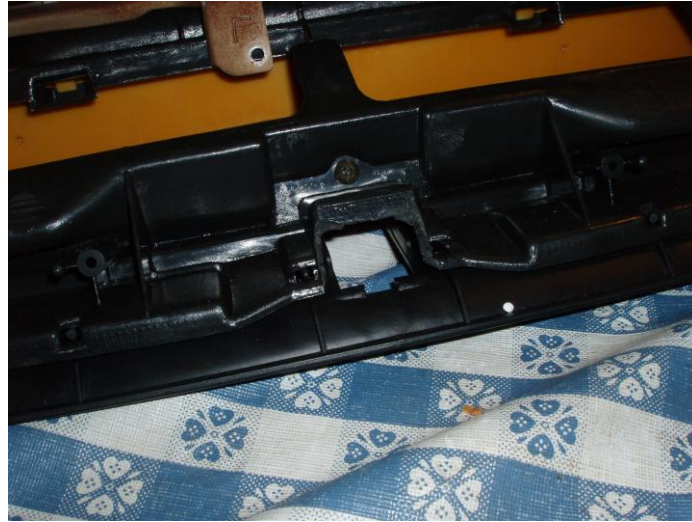
The first exception was that the top center mounting tab was nearly completely gone:

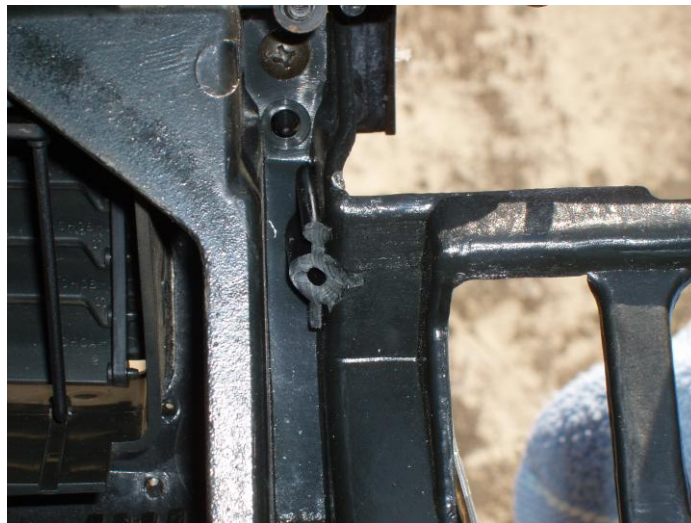
The second exception was the fact that one of the tabs that holds a metal brace on the back was also gone. That tab also holds one of the dash wiring harness mounts in place:

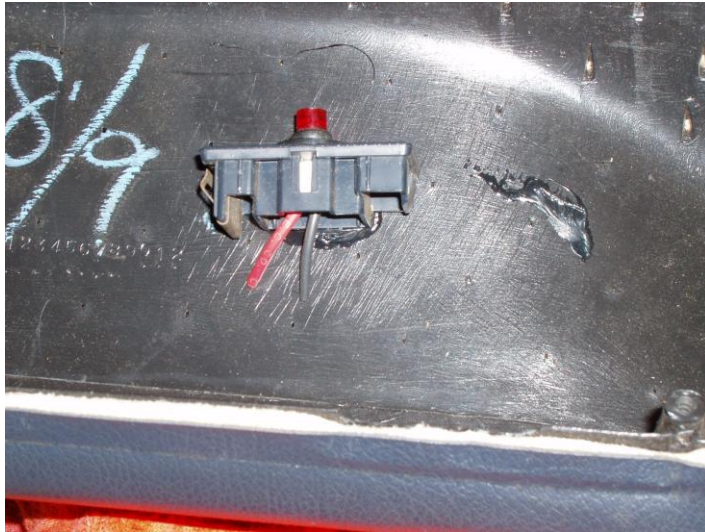
We got a can of ABS cement from the hardware store plumbing department. We put a dab of ABS cement on the inside of a piece of the padded part of the blue HF dash and then used the ABS cement to cement a dash switch blank to the dash part as well. After leaving it to cure overnight, we discovered that the dash is, in fact, made of ABS plastic. The cement fused the switch blank to the inside of the dash part completely:

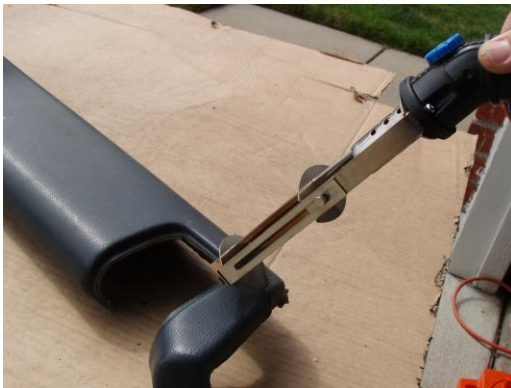
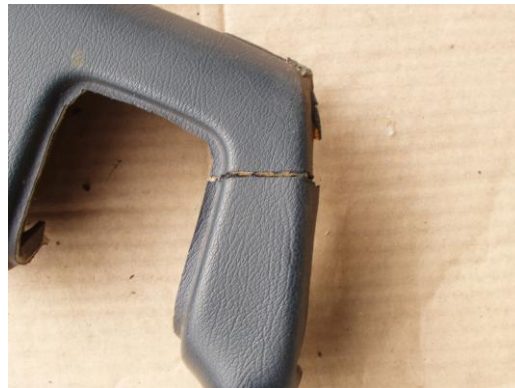
So we now know that the CRX dash is made of ABS plastic. The next question is what is the best way to cut the ABS plastic to make repair pieces and to make things such as bezels. We bought a hot knife from Harbor Freight to see if we could get it to do a clean cut of the ABS dash plastic. We tried it on the padding of the padded part of the dash first:

The hot knife, at its hottest setting, cut the vinyl and the underlying foam padding quite easily. But it was not easy to cut the ABS plastic with the hot knife, even at its hottest setting.

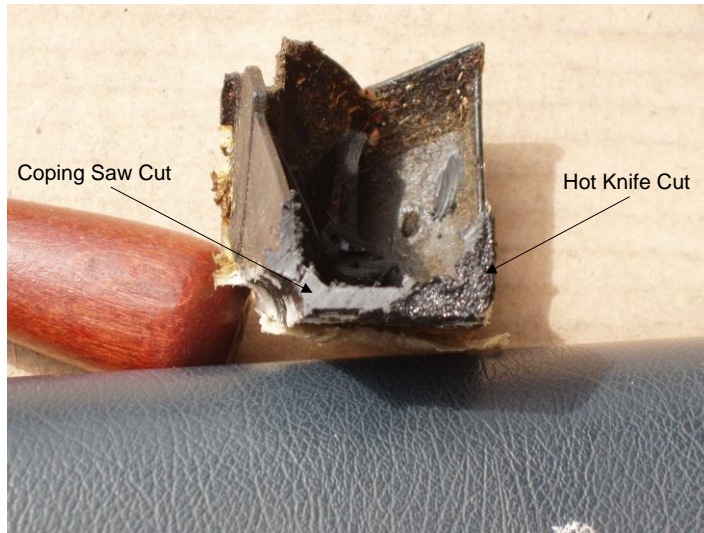
We were able to cut the underlying ABS plastic with the hot knife, but it was extremely slow and made a very messy cut. So we only cut the scrap piece half way and then quickly cut the rest of the way with a coping saw. Here is the comparison of the two cutting techniques:

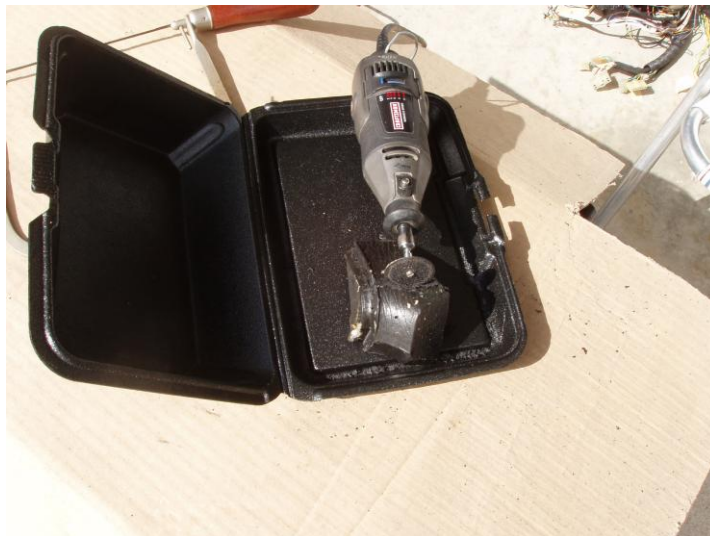
We decided to try cutting the ABS plastic with a Dremel Tool with a carbide cut-off wheel (on a plastic tray to try to catch ABS cuttings):

If you look carefully, you can see how the ABS melts at the cut. But with the Dremel running at a very low setting, the melting problem is not too bad, and the melted plastic is very easy to break off of the cut. The cut is relatively clean after the melted bits are removed. You will see a lot of melting if you run the Dremel at full speed. You will want to save these melted bits of plastic in a small bag or container. You will need plenty of small bits of ABS plastic to use to thicken the ABS cement when you are fusing your repair pieces into place.

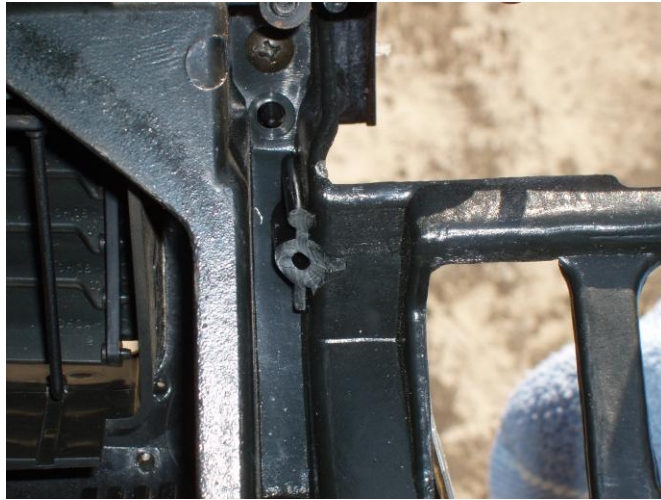
Here is a picture of the broken mounting tab on the back of the dash. It helps hold the metal brace in place and is one of the two tabs the dash harness is connected to:

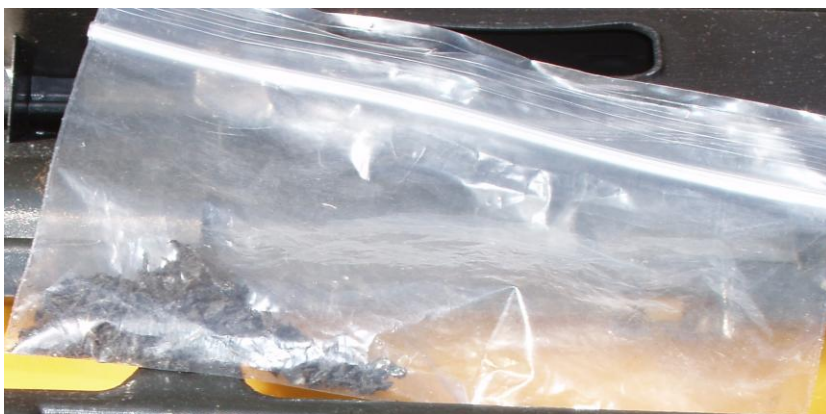
Here are the plastic bits collected from the cuts:
